WHY TRUCKS CATCH FIRE

Author **Dr Peter Hart**, Hartwood Consulting Pty Ltd.

Melbourne
November 2006

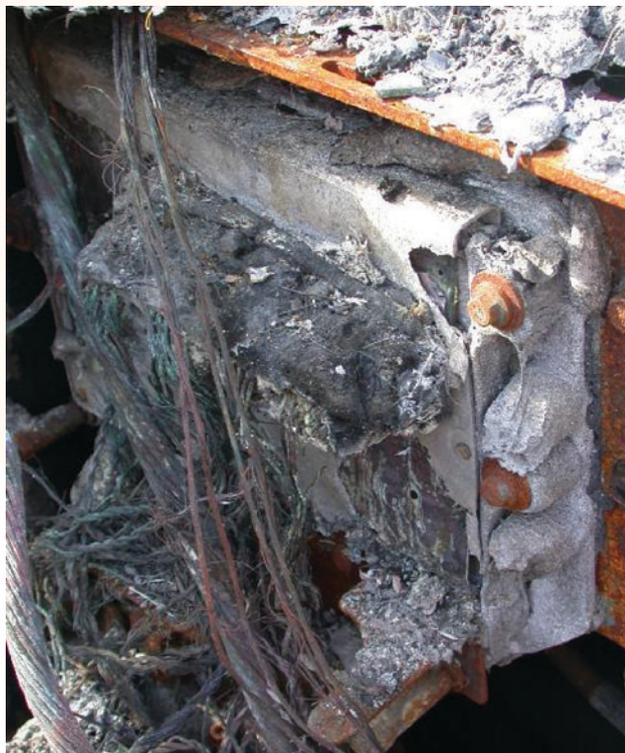
Aluminium can melt during a truck fire. Steel and copper do not, other than at arc points.

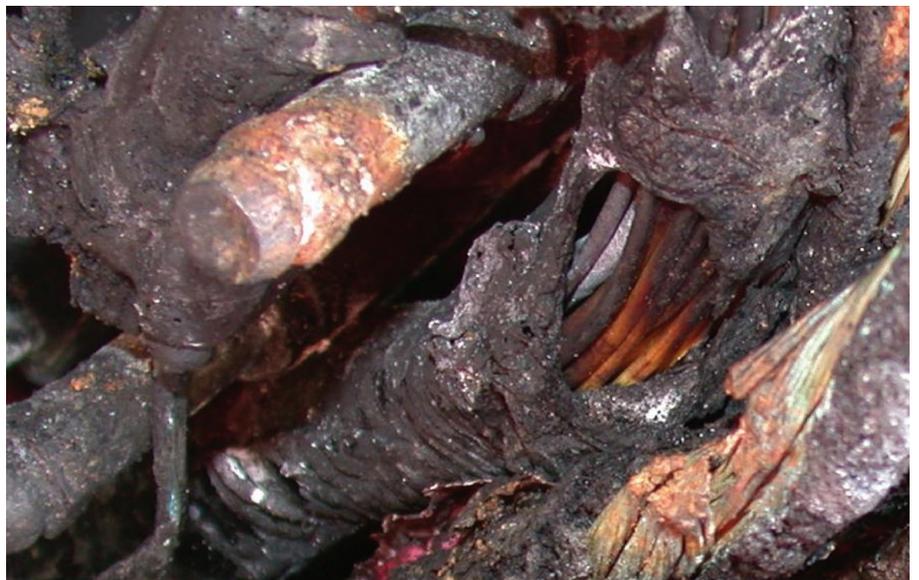
The result of a rub between the alternator cable and an engine stud. The alternator cable was double-insulated with a split-conduit covering but the split worked its way around to the stud position. It had no circuit breaker protection at the battery end.

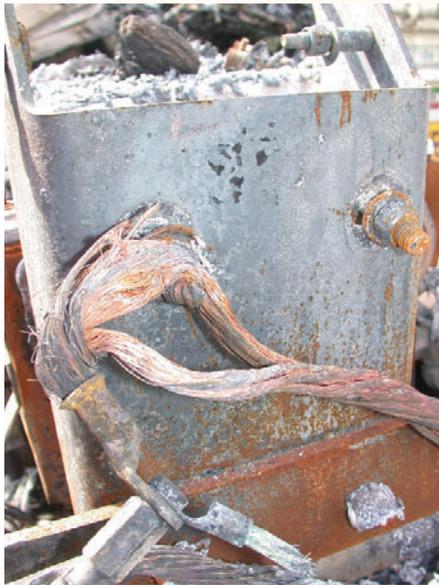
Above left: A starter motor cable tucked between a bolt stud and the battery box cover ignited this fire. The plastic conduit on the cable was split and the split worked around to the stud position. Note that the steel stud melted.

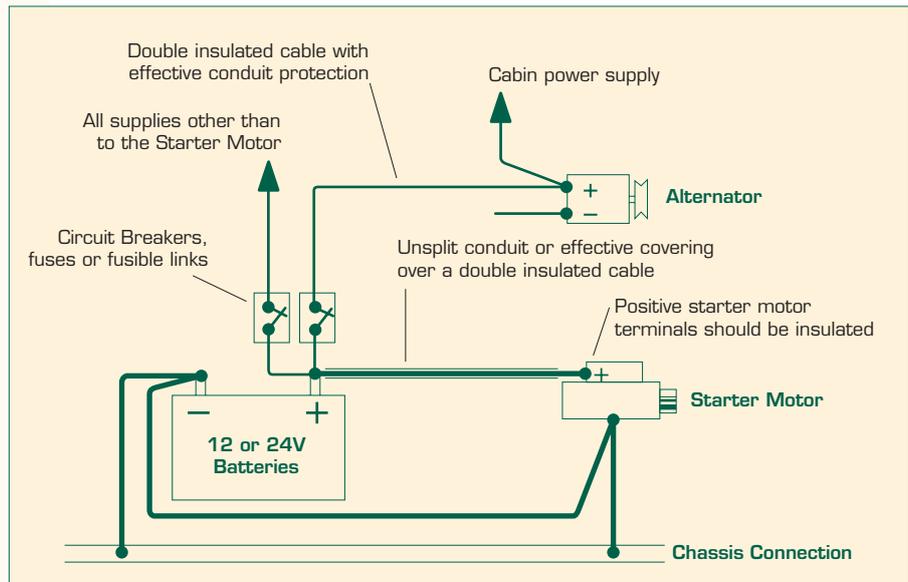
Above right: A suitable electrical protection scheme for the starter, alternator and cabin circuits.

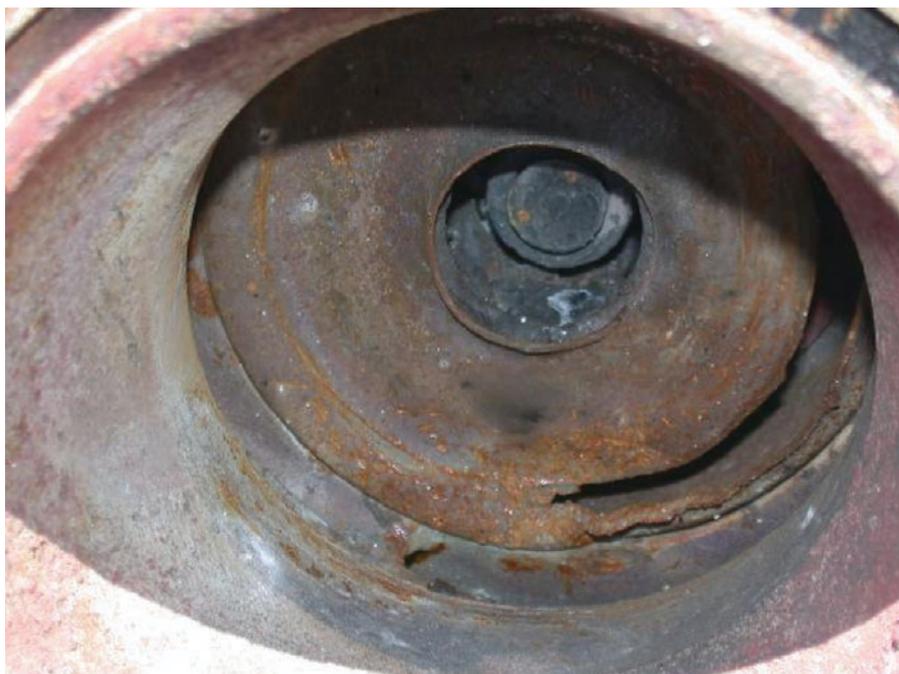
A failed turbo charger blade led to bearing failure and then seal failure. Oil pumped into the exhaust caused an exhaust-fire that destroyed the truck.

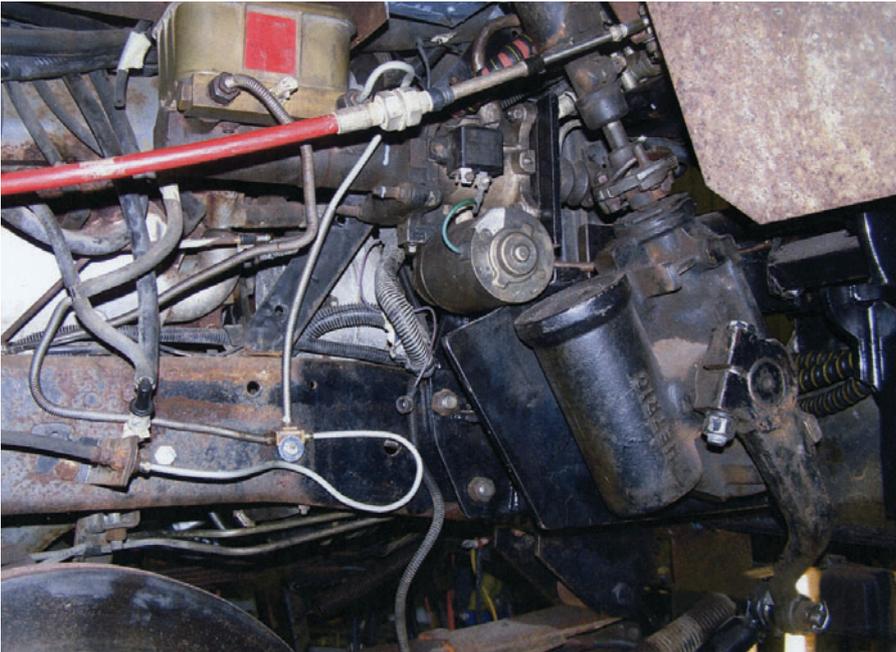
Failure of a brake hose in close proximity to the exhaust extractor pipes probably caused this fire.
