Greetings all. Today's topic is about Tyre fires, pyrolysis and explosions.

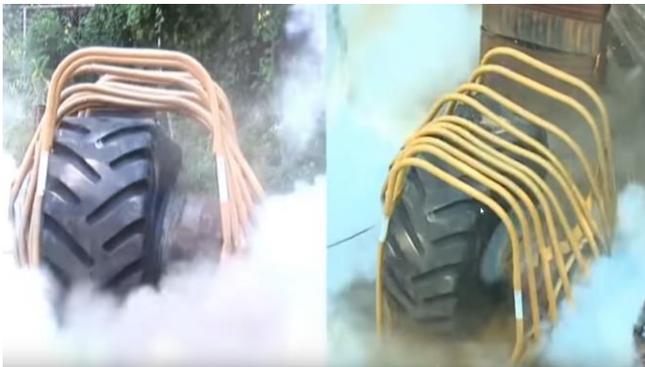
The tyres above are undergoing a controlled test and have exploded and destroyed the steel safety cage around them. Note that these tyres are half the size of a crane tyre. The tyre below is only a truck tyre, but it's clear that the test dummy won't be used again.

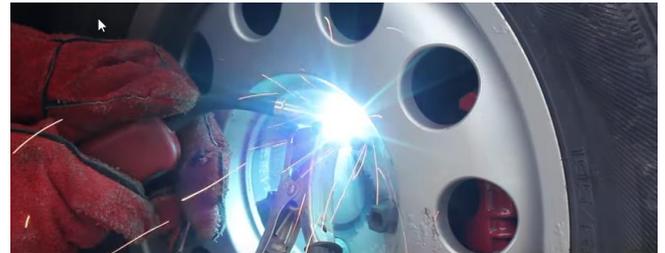
Welding of wheel rims, oxy-heating wheel nuts and overheating brakes are also known causes.

Trucks and other heavy vehicles are just as susceptible as cranes under these circumstances.
