SAFETY COMES AS STANDARD

Safer driving with an Orlaco camera system.

FRONT VISION COLOUR SYSTEM

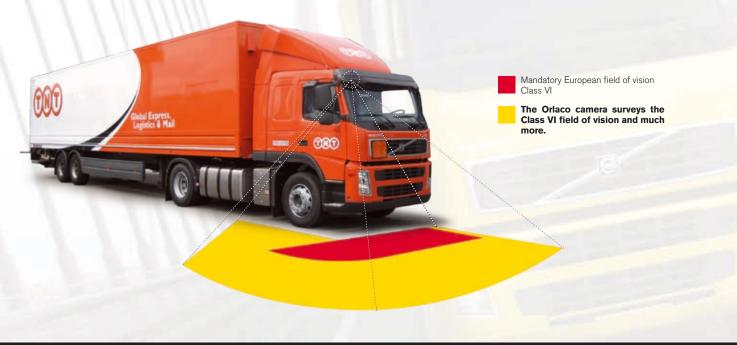
The European guidelines state that if the vehicle is travelling at speeds between 0 and 30 km per hour, the area up to two meters to the front of the vehicle's cabin needs to be fully visible to the driver. A certified front view system must be used to make this mandatory view area visible to the driver. Volvo strongly recommends the use of an Orlaco colour camera which will ensure you comply fully with the latest traffic laws. The camera is compact and inconspicuous and yet it is still able to deliver superior technology and an exceptionally clear, high quality image. The monitor can be installed on top, or integrated into the dashboard with both options aesthetically pleasing to the eye.
